Loss Prevention Safety Tip

By Red River Mutual

POLYBUTYLENE PLUMBING

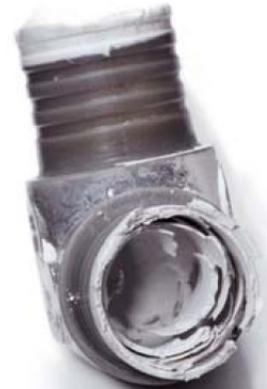
The fitting pictured on the right was still holding up despite the internal decay and flaking. It looked fine on the outside, but fortunately the homeowner decided to replace the poly system before the problems started.

Although replacement can be done at any time, it's easier and less expensive if you replace it while the house is vacant. You may even be able to roll the cost into your mortgage. Replacement entails abandoning all poly pipes and installing a new system. You should look for a company that specializes in poly replacement, not just plumbing in general.

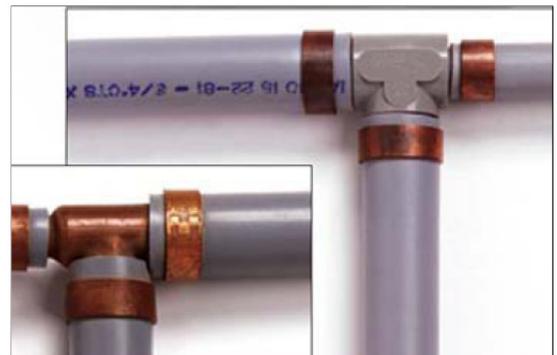
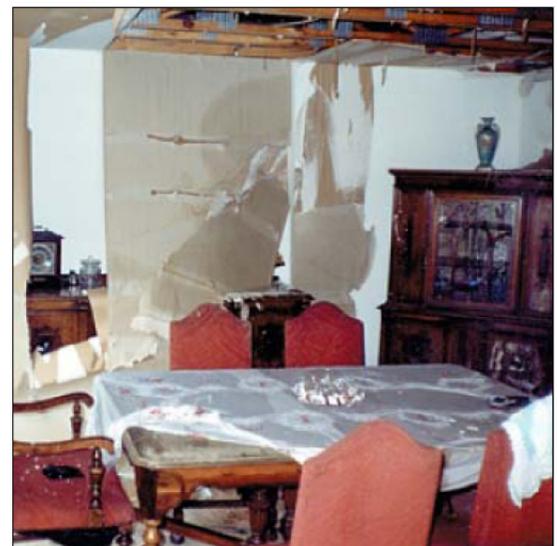
Even if you know you have poly pipes, you still can't tell what condition they're in just by looking at or squeezing them because the problems occur on the inside of the pipes. Failures may occur in systems with plastic fittings, metal fittings, and manifold-type systems that look fine even to the trained eye.

You must prioritize your home maintenance requirements and budget accordingly. Unlike most other maintenance issues, delayed replacement of poly may have substantial consequences. Due to the many documented cases of leaks, plumbing experts recommend replacing poly pipes.
